Office of Structural Materials

Contract #: 04-0120F4Cty: SF/ALA Rte: 80 PM: 13.2/13.9File #: 69.28**WELDING INSPECTION REPORT****Resident Engineer:**Pursell, Gary**Address:** 333 Burma Road**City:** Oakland, CA 94607**Report No:** WIR-011150**Date Inspected:** 03-Jan-2010**Project Name:** SAS Superstructure**OSM Arrival Time:** 700**Prime Contractor:** American Bridge/Fluor Enterprises, a JV**OSM Departure Time:** 1900**Contractor:** Zhenhua Port Machinery Company, Ltd (ZPMC), Changxing Island **Location:** Shanghai**CWI Name:** ZPMC and ABF**CWI Present:** Yes No**Inspected CWI report:** Yes No N/A**Rod Oven in Use:** Yes No N/A**Electrode to specification:** Yes No N/A**Weld Procedures Followed:** Yes No N/A**Qualified Welders:** Yes No N/A**Verified Joint Fit-up:** Yes No N/A**Approved Drawings:** Yes No N/A**Approved WPS:** Yes No N/A**Delayed / Cancelled:** Yes No N/A**Bridge No:** 34-0006**Component:** OBG**Summary of Items Observed:**

WELDING INSPECTION REPORT

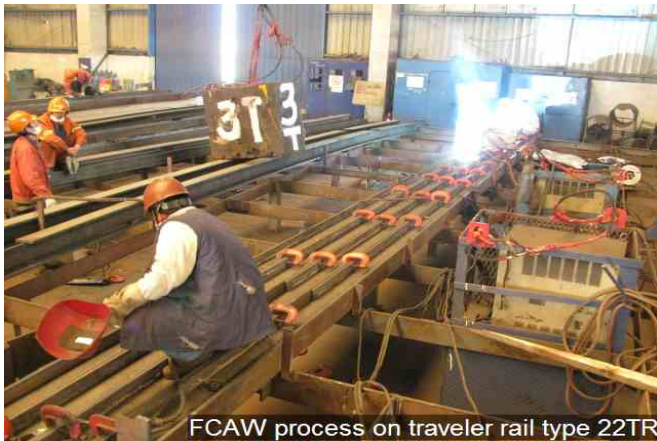
Traveler rail: - Caltrans QA inspector observed three ZPMC welders performed FCAW process on the flange to web plate of traveler rail #22TR3-001, 22TR3-004, 22TR4-004, 22TR2-001 and 22TR1-001. This 22TR type component has been changed design to all CJP weld along on both side of top and bottom flanges. All the welding areas have been pre-heating prior FCAW welding. The FCAW process were monitored and recorded by ZPMC and ABF QC inspector. Based on Caltrans QA Inspector observations, no discrepancies were noted.

FCAW process on traveler rail type 22TR

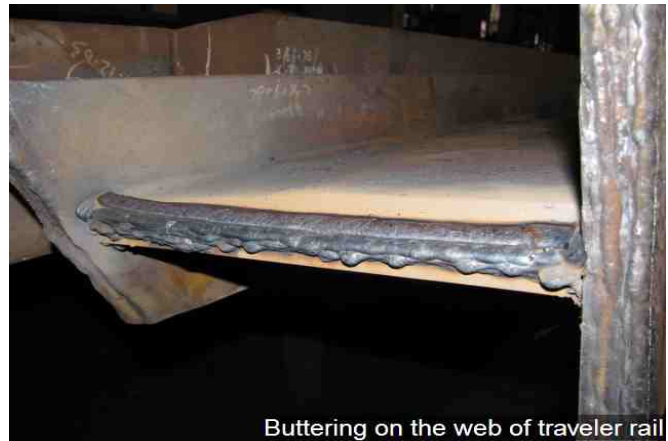
Traveler rail: - Caltrans QA inspector observed two ZPMC welders performed FCAW build up weld metal (buttering) process on the web of traveler rails with CWR # B-CWR-982. The traveler rails ID are #10TR3-017, 11TR7-001 and 10TR3-014. The buttering size is along the edge of web with 10mm~20mm width. All of buttering areas have been pre heating prior FCAW welding. The FCAW process were monitored and recorded by ZPMC and ABF QC inspector. Based on Caltrans QA Inspector observations, no discrepancies were noted.

Buttering on the web of traveler rail
